Simplified and Efficient Fixture Removal with the All-in-One Remover Kit

✓ Case Summary 🔍

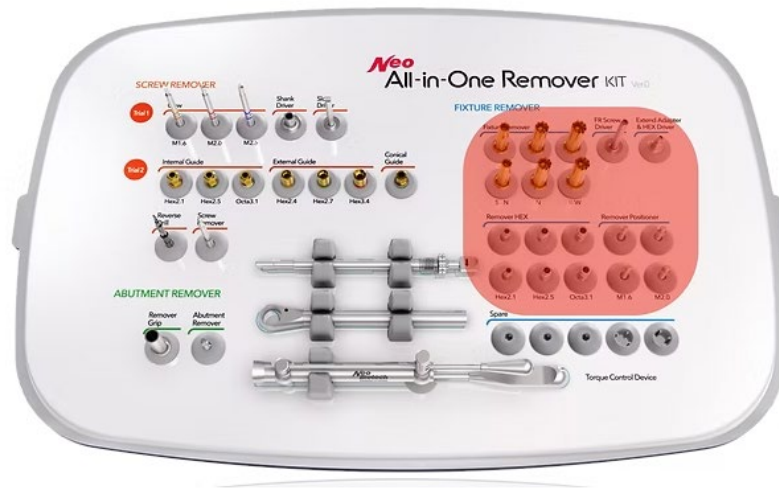
[All-in-One Remover Kit]

- Fixture Remover Positioner • Fixture Remover Hex • Extend Adapter & Hex Driver • Fixture Remover

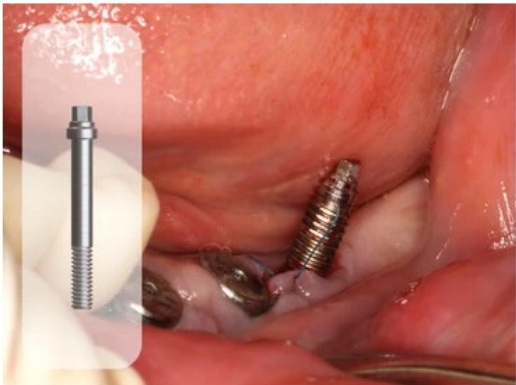
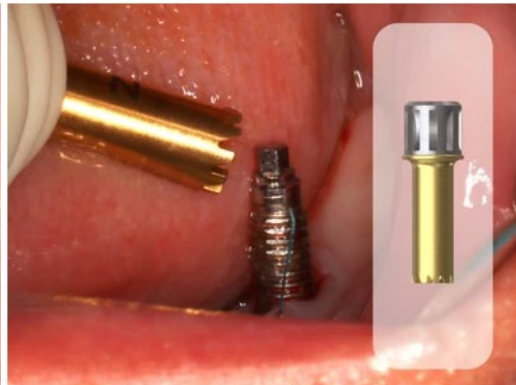
- Then, the **Extend Adapter & Hex Driver** were removed, and the **Fixture Remover** was connected to the fixture at the removal site.

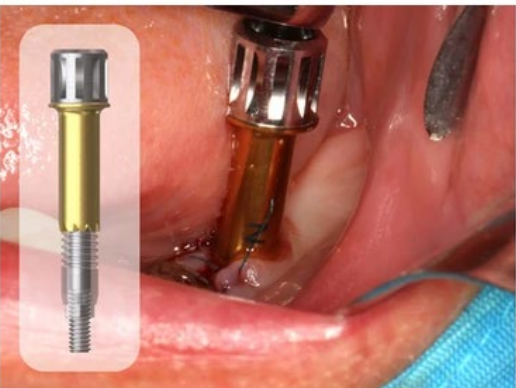
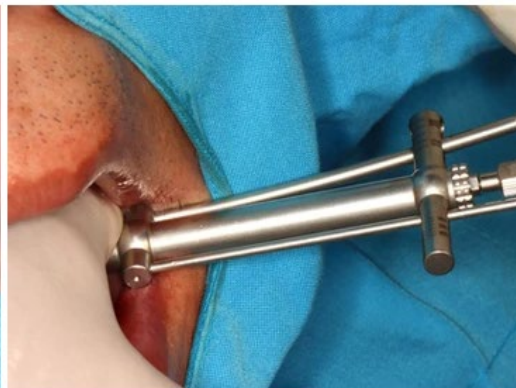
- The **Fixture Remover** was turned **counterclockwise** to lock, then gradually tightened to 200N/cm. Upon reaching 200N/cm, a 5-minute rest was taken before repeating the tightening process until the fixture was removed.

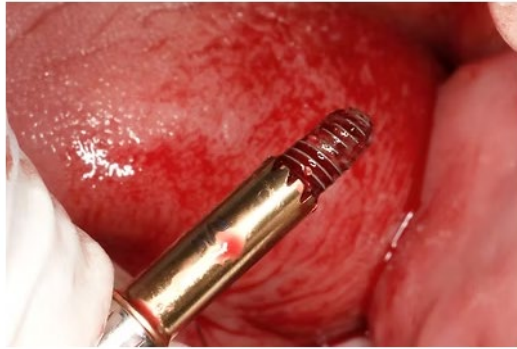
- The implant was removed precisely and atraumatically, preserving bone integrity. The surgical site was closed with two sutures.
