# Single Implant Restoration Simplified with the PickCap Impression Kit

The patient presented with a previously endodontically treated mandibular right first molar (#46), showing signs of endodontic failure and secondary caries. The tooth was extracted, and an implant was immediately placed in the extraction socket. An implant impression was taken with the PickCap Kit one month after surgery. A zirconia crown was fabricated and successfully delivered as the final prosthesis.

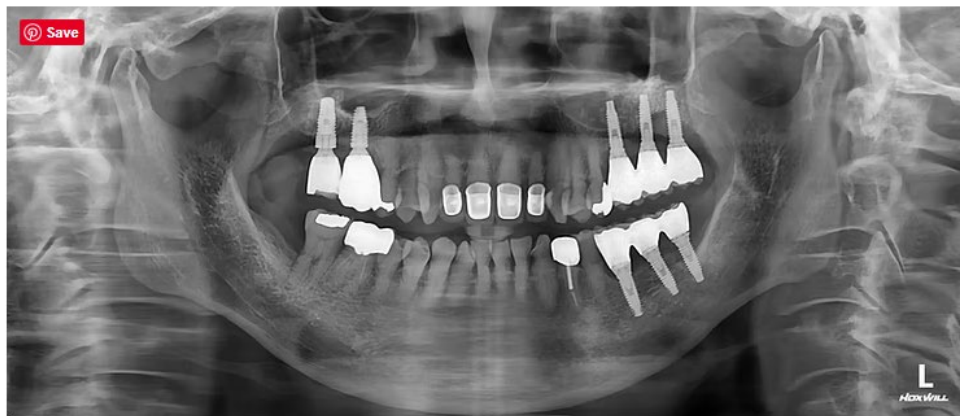
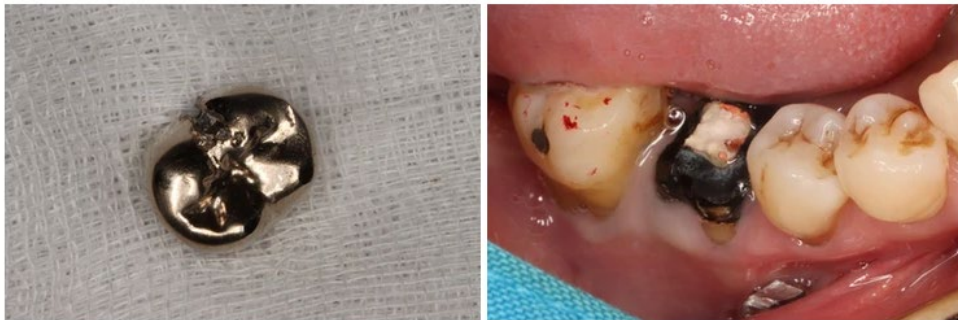
### 1 Pre-Op

- The preoperative panoramic and intraoral images revealed secondary caries on tooth #46, which had previously undergone root canal treatment. Upon removal of the crown, extensive secondary caries was identified.

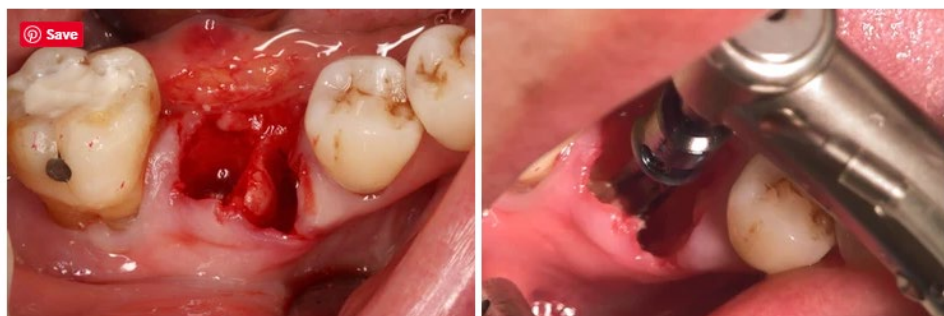
- Tooth #46 was atraumatically extracted to preserve the socket for immediate implant placement.
- Sequential drilling was carefully performed to maintain socket integrity and ensure optimal implant positioning.

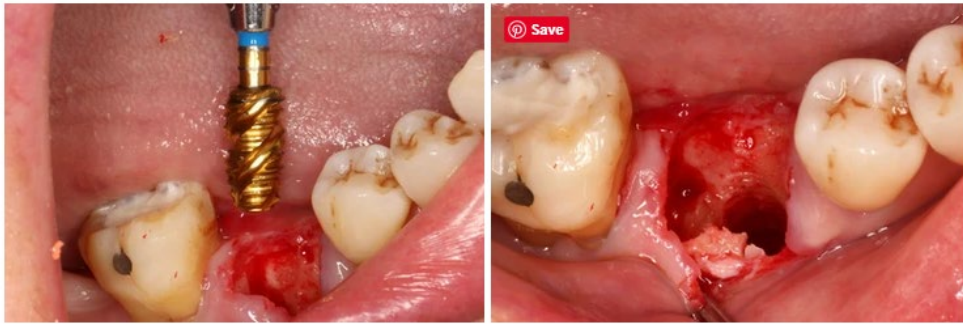
- Due to the D221 bone density, a 5.0 Maxy drill was used to prevent over-compression.
- The formed thread can be clearly observed.

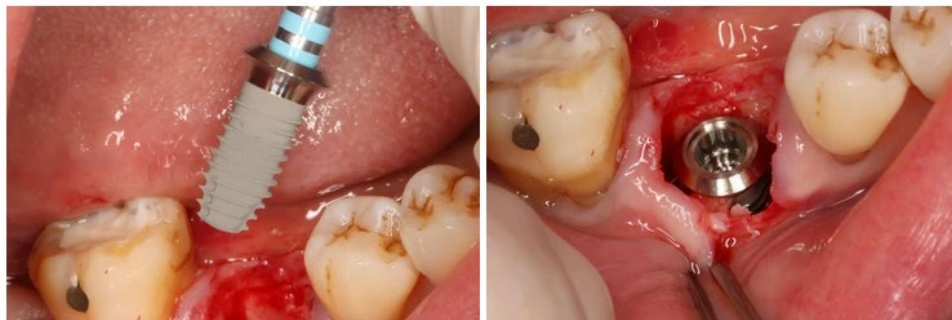
- A  $\varnothing 5.0 \times 10$ mm IT-III implant with a 1.8 mm G-collar was placed.
- Good primary stability was achieved with an insertion torque of 40N/cm.

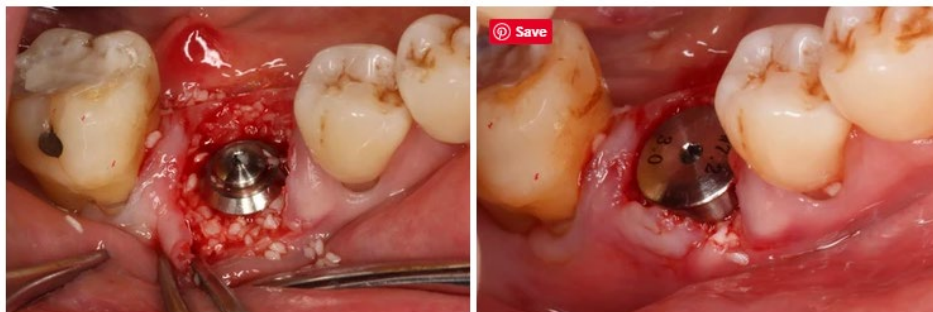
- Following cover screw placement, bone grafting was performed using Neo Bone (allograft).
- A healing abutment was then connected.

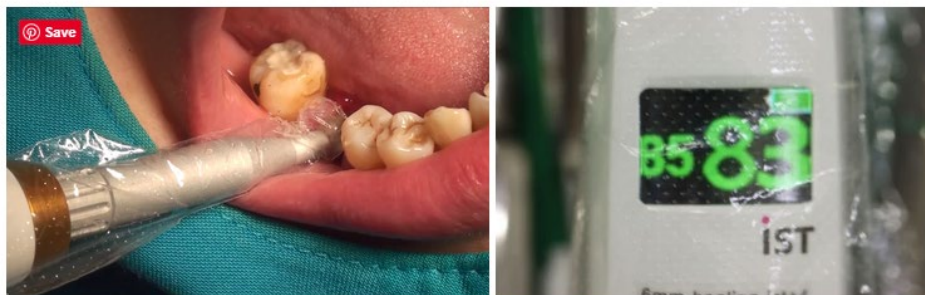
- Initial stability was measured using AnyCheck.
- The measured value was 83, and after adjusting for collar height, the corrected value was 85.

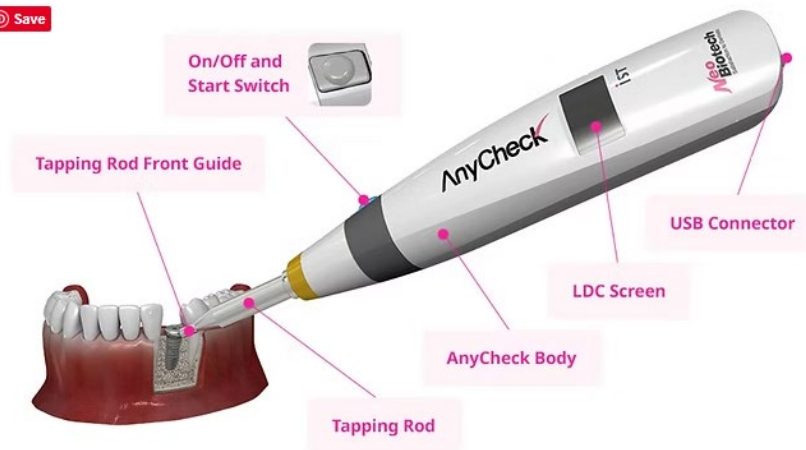
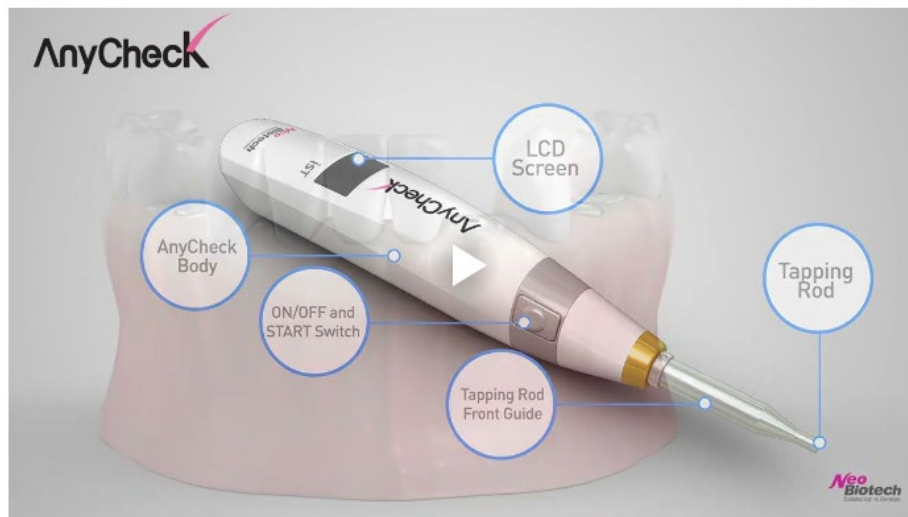
## AnyCheck

Dental implant stability meter (tapping-motion) for measuring stability of an implant without disconnecting the healing abutment.

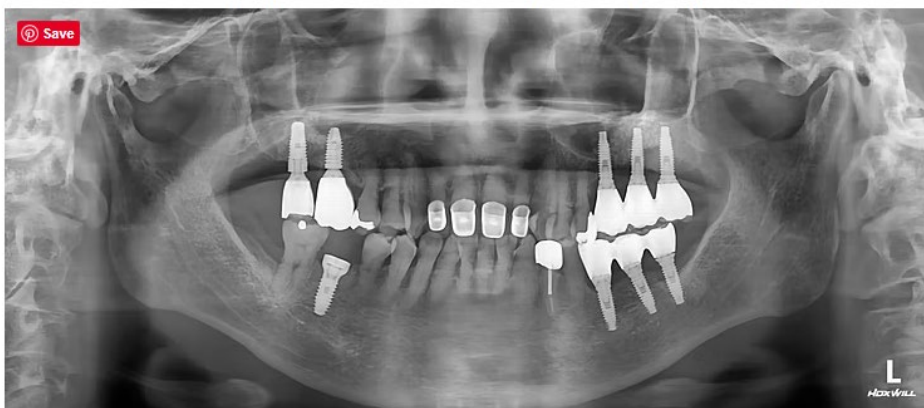
### 3 Post-Op

- Clinical and radiographic examinations were performed postoperatively.

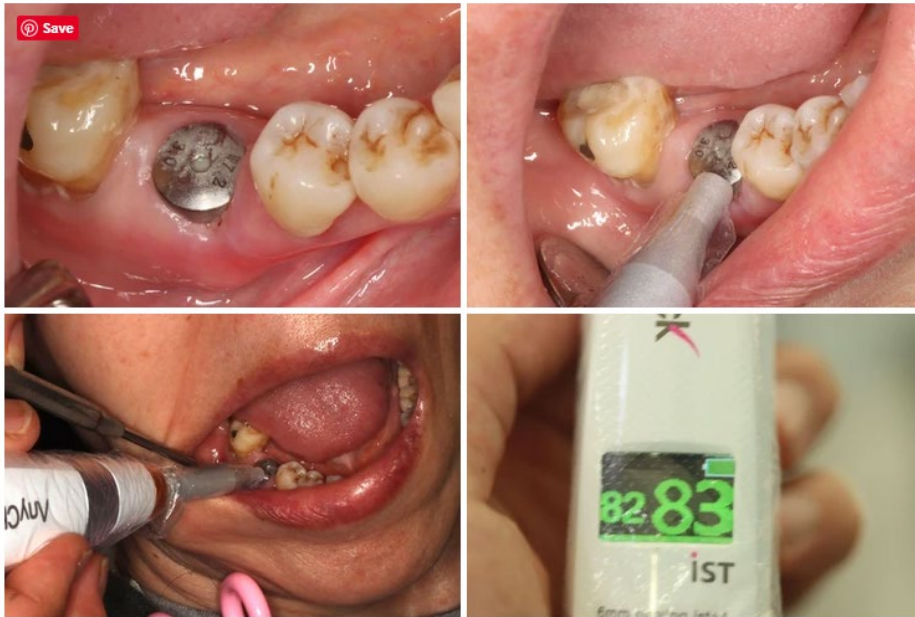
#### 4 Check-Up

- Two weeks after surgery, initial stability was well maintained without reduction.

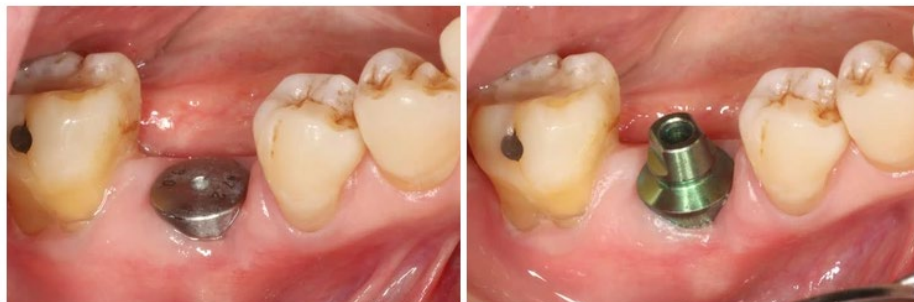
- 1 month after surgery, the soft tissue had healed well.
- After removal of the healing abutment, a coping of appropriate diameter and gingival height was selected and connected.

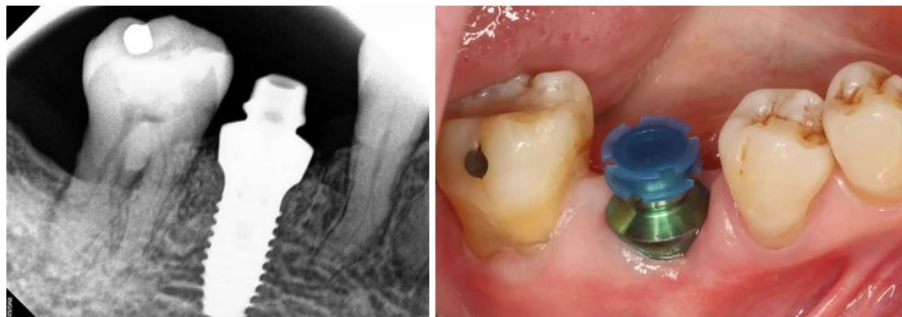
- A periapical radiograph was taken to verify proper coping connection.
- After connecting the cap to the coping, occlusal and proximal clearances were checked.

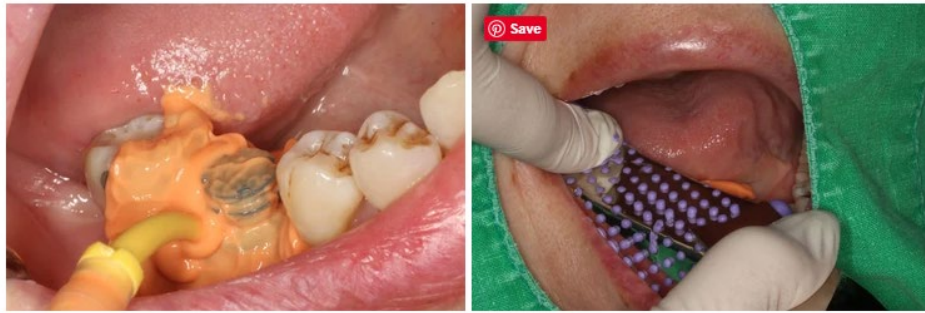
- A rubber impression was taken.

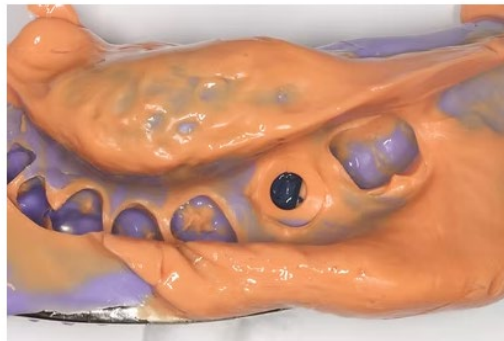
- After impression removal, the PickCap remained in the impression. The coping was unscrewed, joined with the lab analogue, and repositioned using the PickCap as a guide.

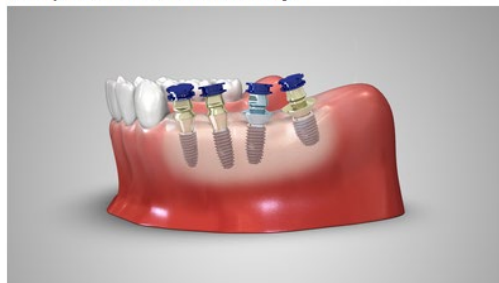
### ▼ PickCap Impression Kit

The Pick Cap Impression Kit consists of Impression Copings of various diameters and lengths. It is used to acquire oral impressions conveniently.

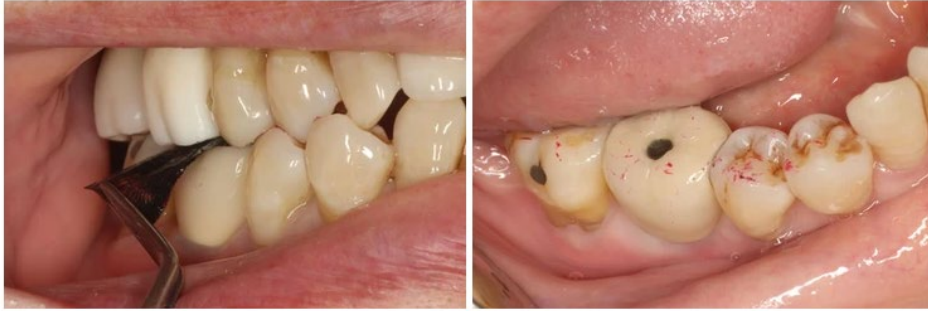
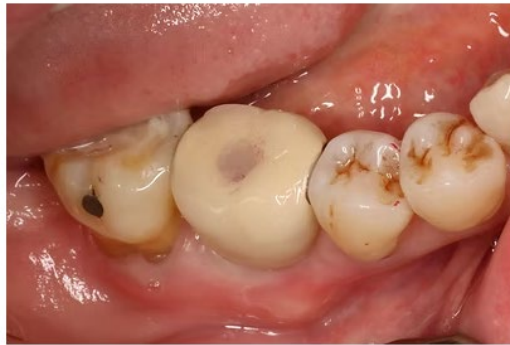
## 6 Final Restoration

- The final prosthesis was delivered 6 weeks after surgery.

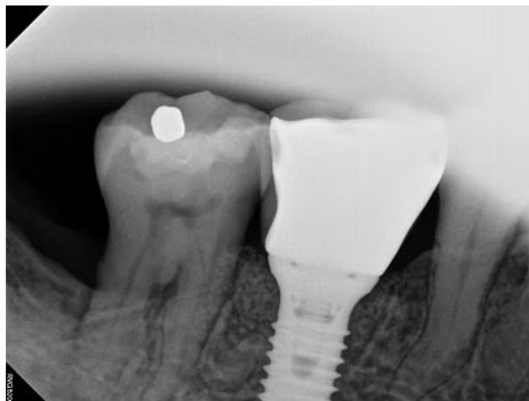
- Radiographic examination after final restoration

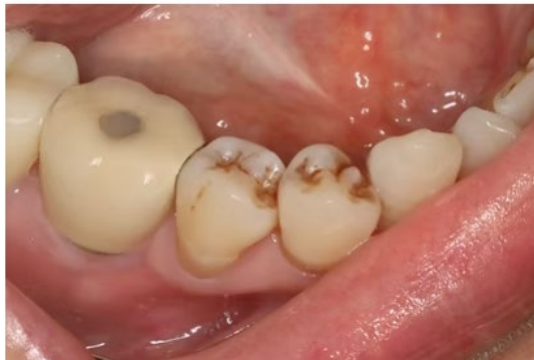
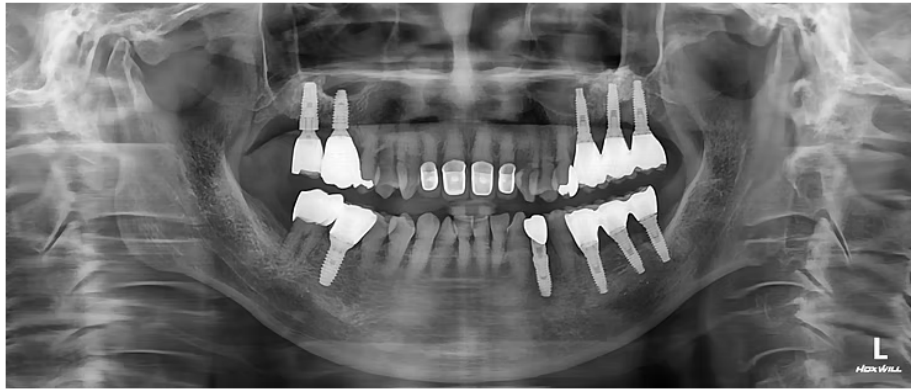
## 7 Follow-Up

- 1-year follow-up panoramic and intraoral images showed stable outcomes with no complications.
